Inspection Report

SAMPLE REPORT

123 Sample Drive

Harland Home Inspection

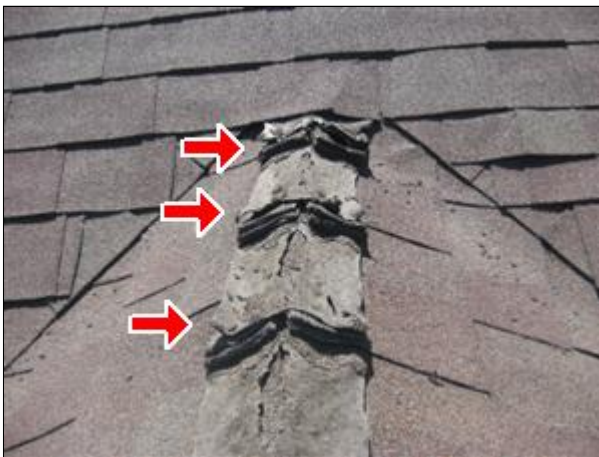
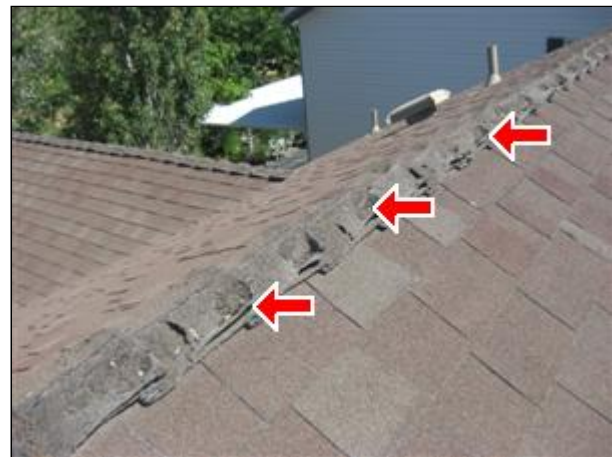
1.0 ROOF COVERINGS

The main body of the roof was inspected and showed no signs of deficiency. However, the ridge caps show signs of extensive wear and appear to be weather beaten. The interior side of the roof structure shows no sign of any water penetration at the time of inspection. It is recommended that this issue be carefully monitored and replaced or repaired as needed by a licensed roofing installer.

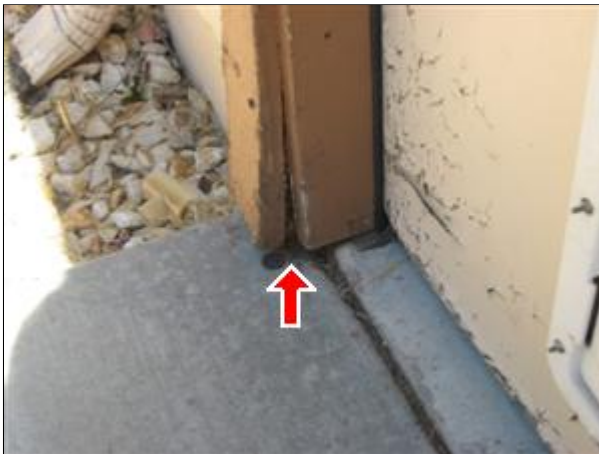
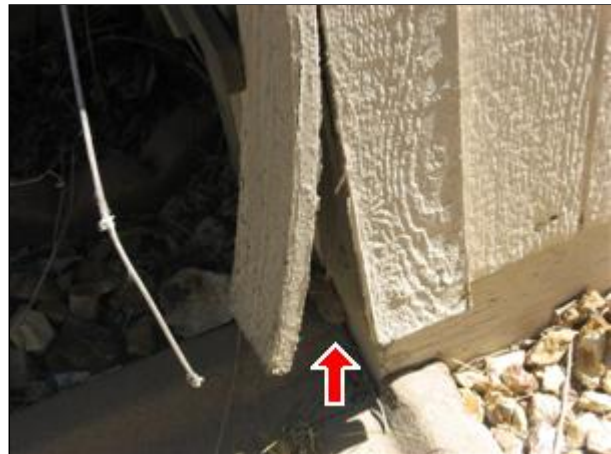
2.0 WALL CLADDING FLASHING AND TRIM

The trim at the rear NW and NE side of the house show signs of curling and are detached from the main exterior wall structure. It is suggested that licensed contractor or qualified handy man replace these boards to prevent any water infiltration into the foundation and or wall system.

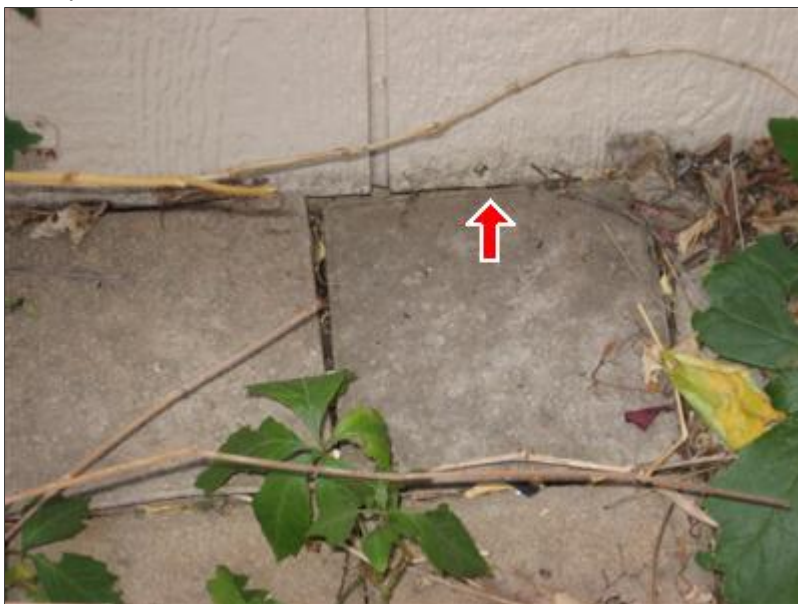
2.3 Picture 1

The stone pavers to the left of the rear door are up against the exterior wall structure. This may cause water to drain back behind the wall and infiltrate the foundation and wall structure. It is recommended that a licensed contractor or certified handy man repair or replace these stones.

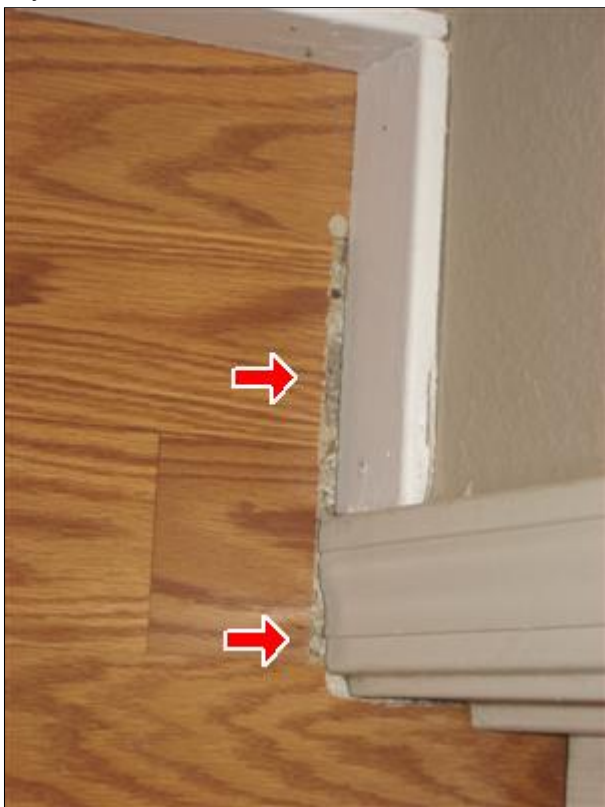
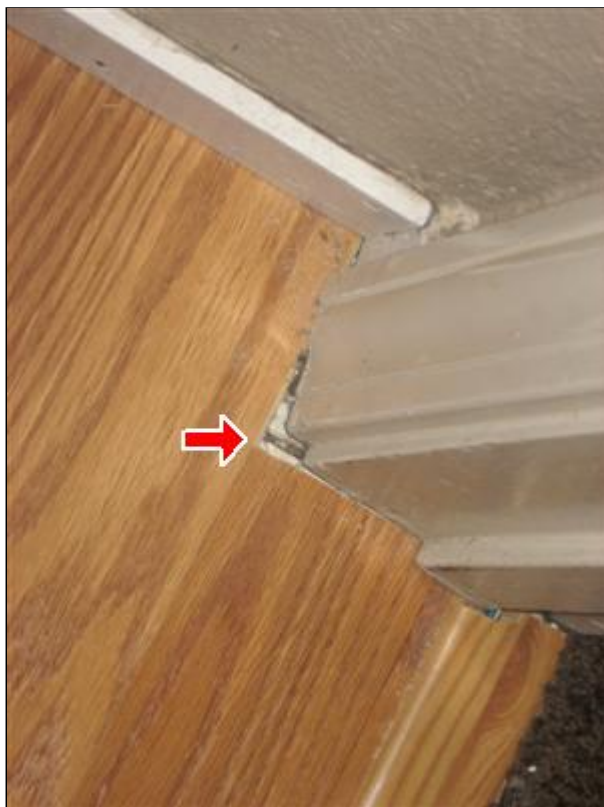
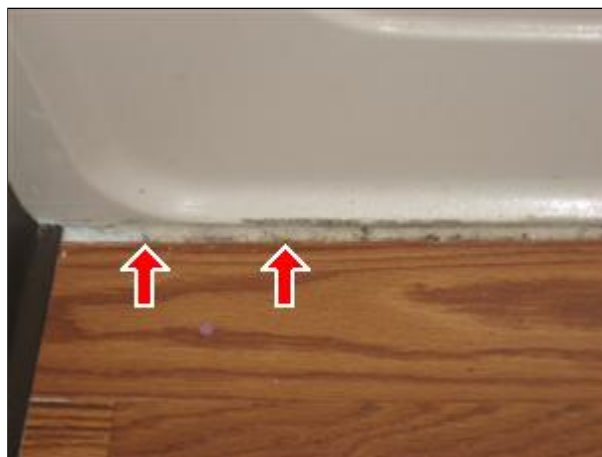
4.2 FLOORS

There are some areas, main hall and front bathroom, where the laminate flooring does not meet the wallboard. It is recommended that a qualified handy man seal these areas with wallboard and or water proof caulk (in the bath) to prevent any water infiltration to the subfloor.

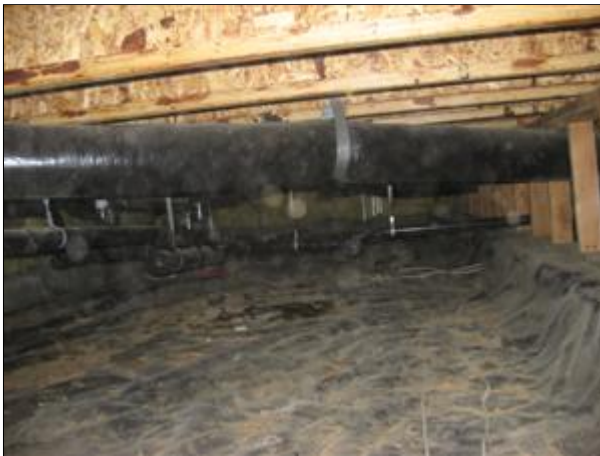
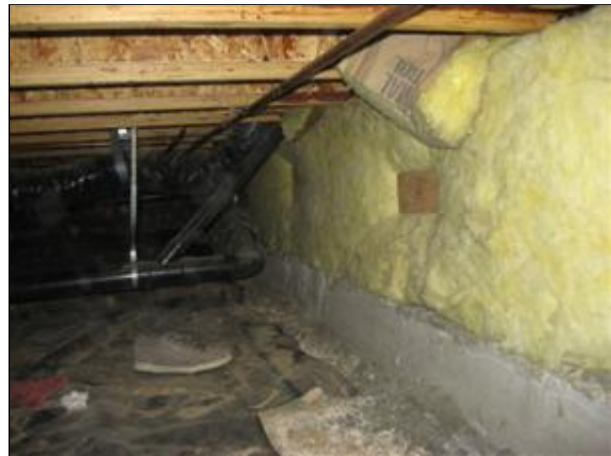
The vapor barrier was intact and the crawl showed no signs of water infiltration.

The insulation along the exterior walls of the crawlspace was intact and showed no signs of water infiltration at the time of inspection.

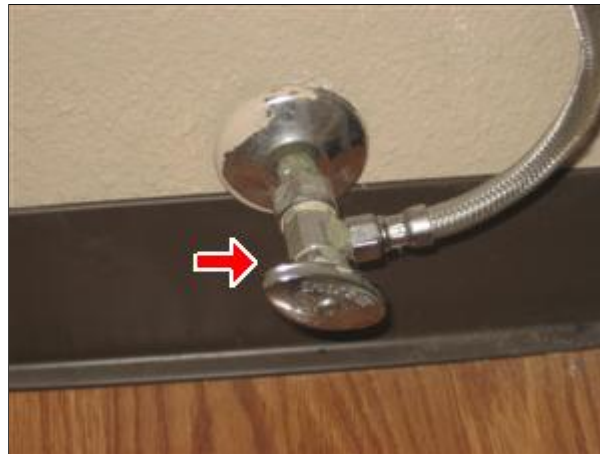
6.1 Picture 1

The water supply in the guest bath is leaking at the main shut off valve. To prevent any water damage to the floor or wall structure it is recommended that a licensed plumber or qualified handy man repair or replace as soon as possible.

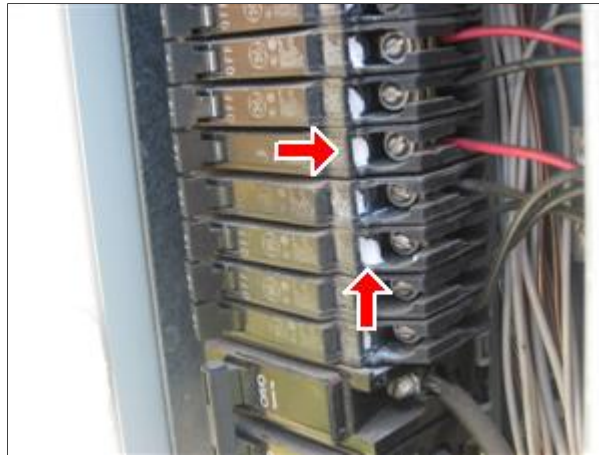
7.1 Picture 1

The circuit breakers at the main distribution panel show signs of corrosion on most all the circuit breakers. It is recommended that a licensed electrician evaluate this issue as soon as possible and repair or replace as needed.

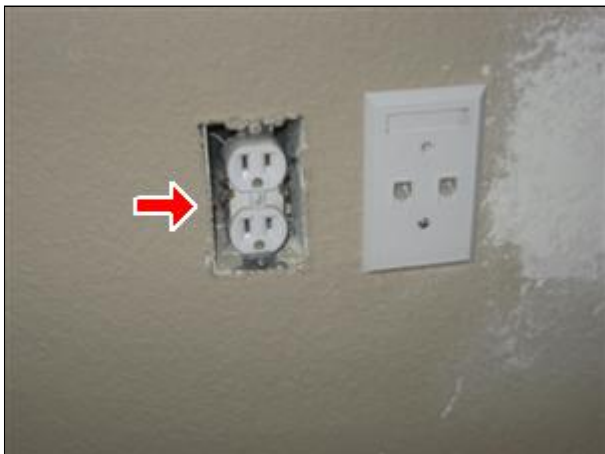
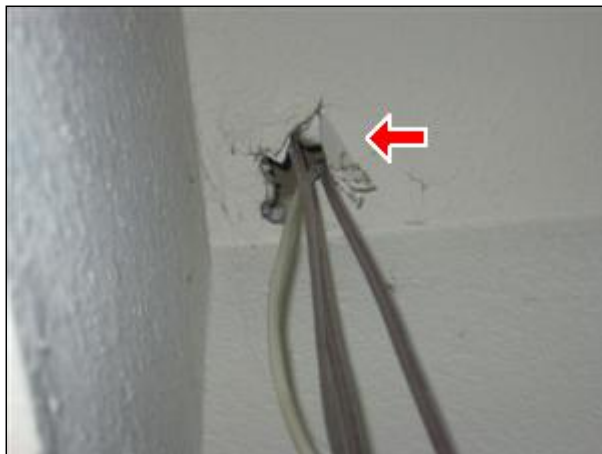
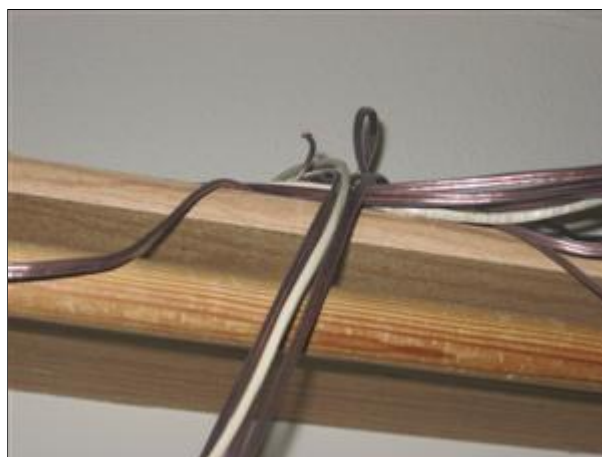
Ceiling fan in the main living area did not work when the wall switch was used. Pull cords were too high to reach to properly evaluate the proper function of the fan. It is recommended that the pull cords be used in conjunction with the wall switch to evaluate the function of this fan.

Outlet in the master bed room is missing the receptacle cover. It is recommended that a cover be installed as soon as possible to prevent an accidental electrical shock. **This is a life safety issue!**

There are a number of wires protruding from the ceiling inside the master bed room closet. These appear to be speaker wires. Speaker wires do carry electrical current. It is recommended that a qualified handy man either attach these wires to speakers or remove them.

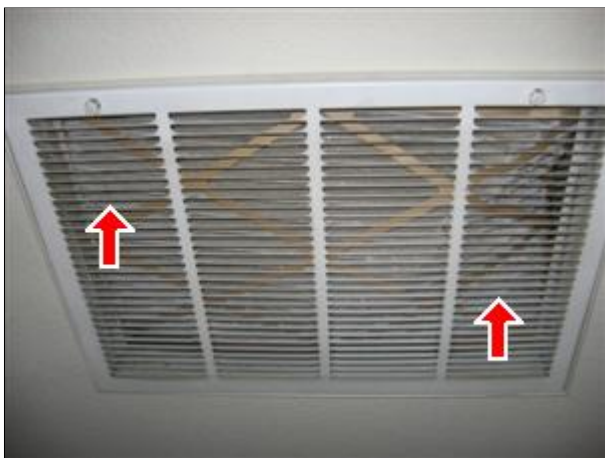
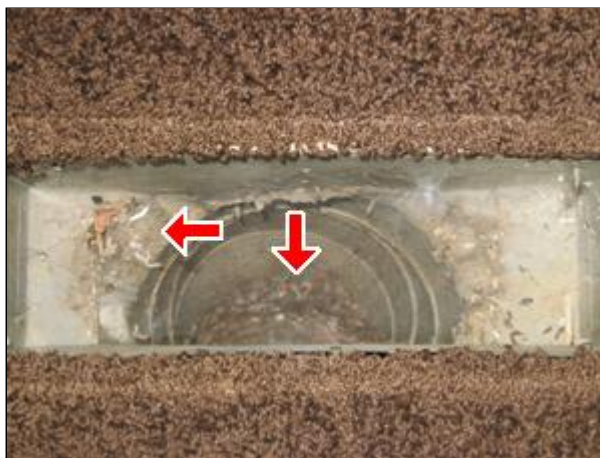
The main return air vent located in the main hall ceiling is dirty and filled with debris. It is recommended that this filter be change as soon as possible to maintain the proper flow of air back to the heating and cooling system as well as distributing clean air throughout the home. It will also help the heating and cooling system work more efficiently.

The floor vent in the master bed room and main living area shown to have small amount of debris in them. It is recommended that all vents be cleaned out to ensure clean and uncontaminated air flow into the room.

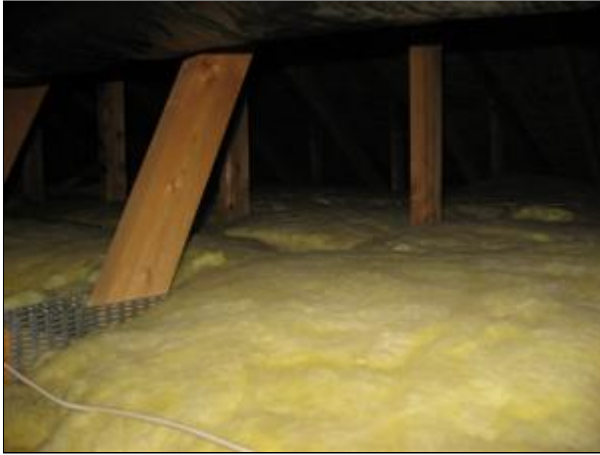
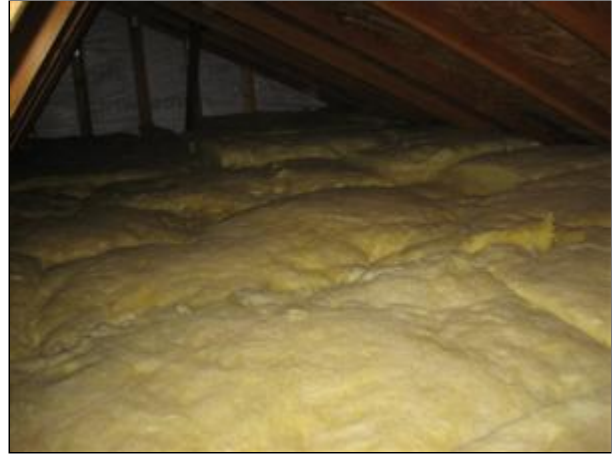
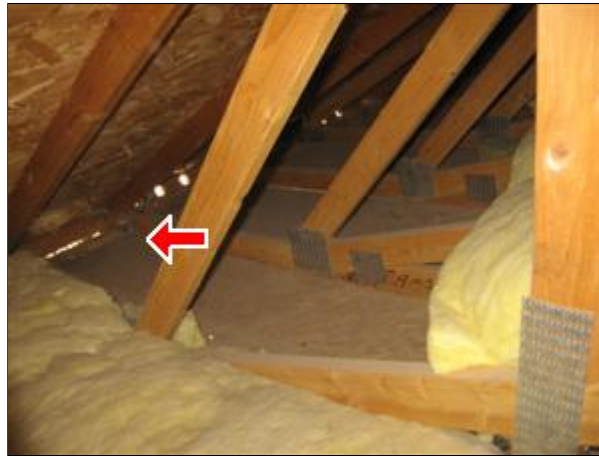
The attic was well insulated and it is determined that the "R" (resistance) factor exceeds the code for this area of R38.

3 batts were pulled up on the East side of the attic. It appears it was to spray for wasps or such. The insulation was not replaced at time of inspection to facilitate any eradication of the insect.

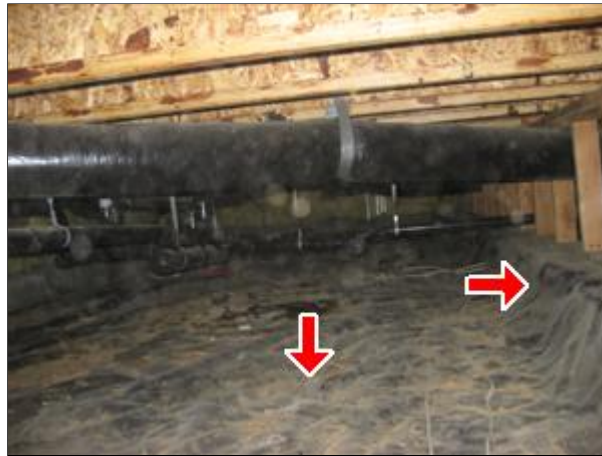
9.2 Picture 1

The vapor barrier in the crawl space was intact through the area and showed no signs of moisture or water.

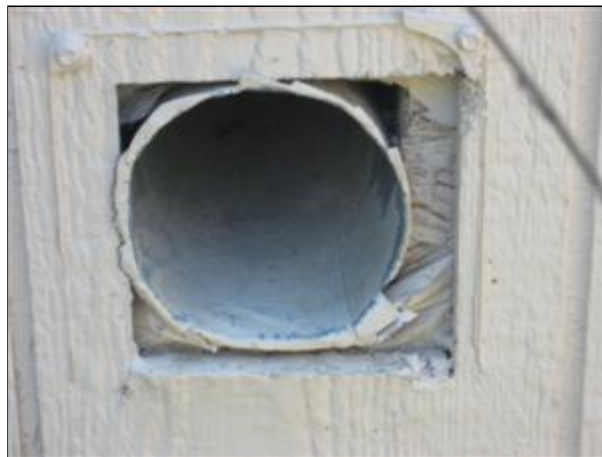
9.4 Picture 1

The dryer vent located on the East side of the house is open and without of a cover. It is highly recommended that a cover be installed before a dryer is installed. This will help to prevent this vent from being cluttered with debris or a small animal getting caught inside and preventing the proper venting of the dryer. **This is a life safety issue. A clogged dryer vent can cause a potential fire.**
